SUBJECT: **Parcel B Supplemental Sampling and Analysis Plan**
Boeing C-6 Facility, Los Angeles, California

Parcel B Supplemental Sampling and Analysis Plan

Boeing Realty Corporation
C-6 Facility
Los Angeles, California
March 1998

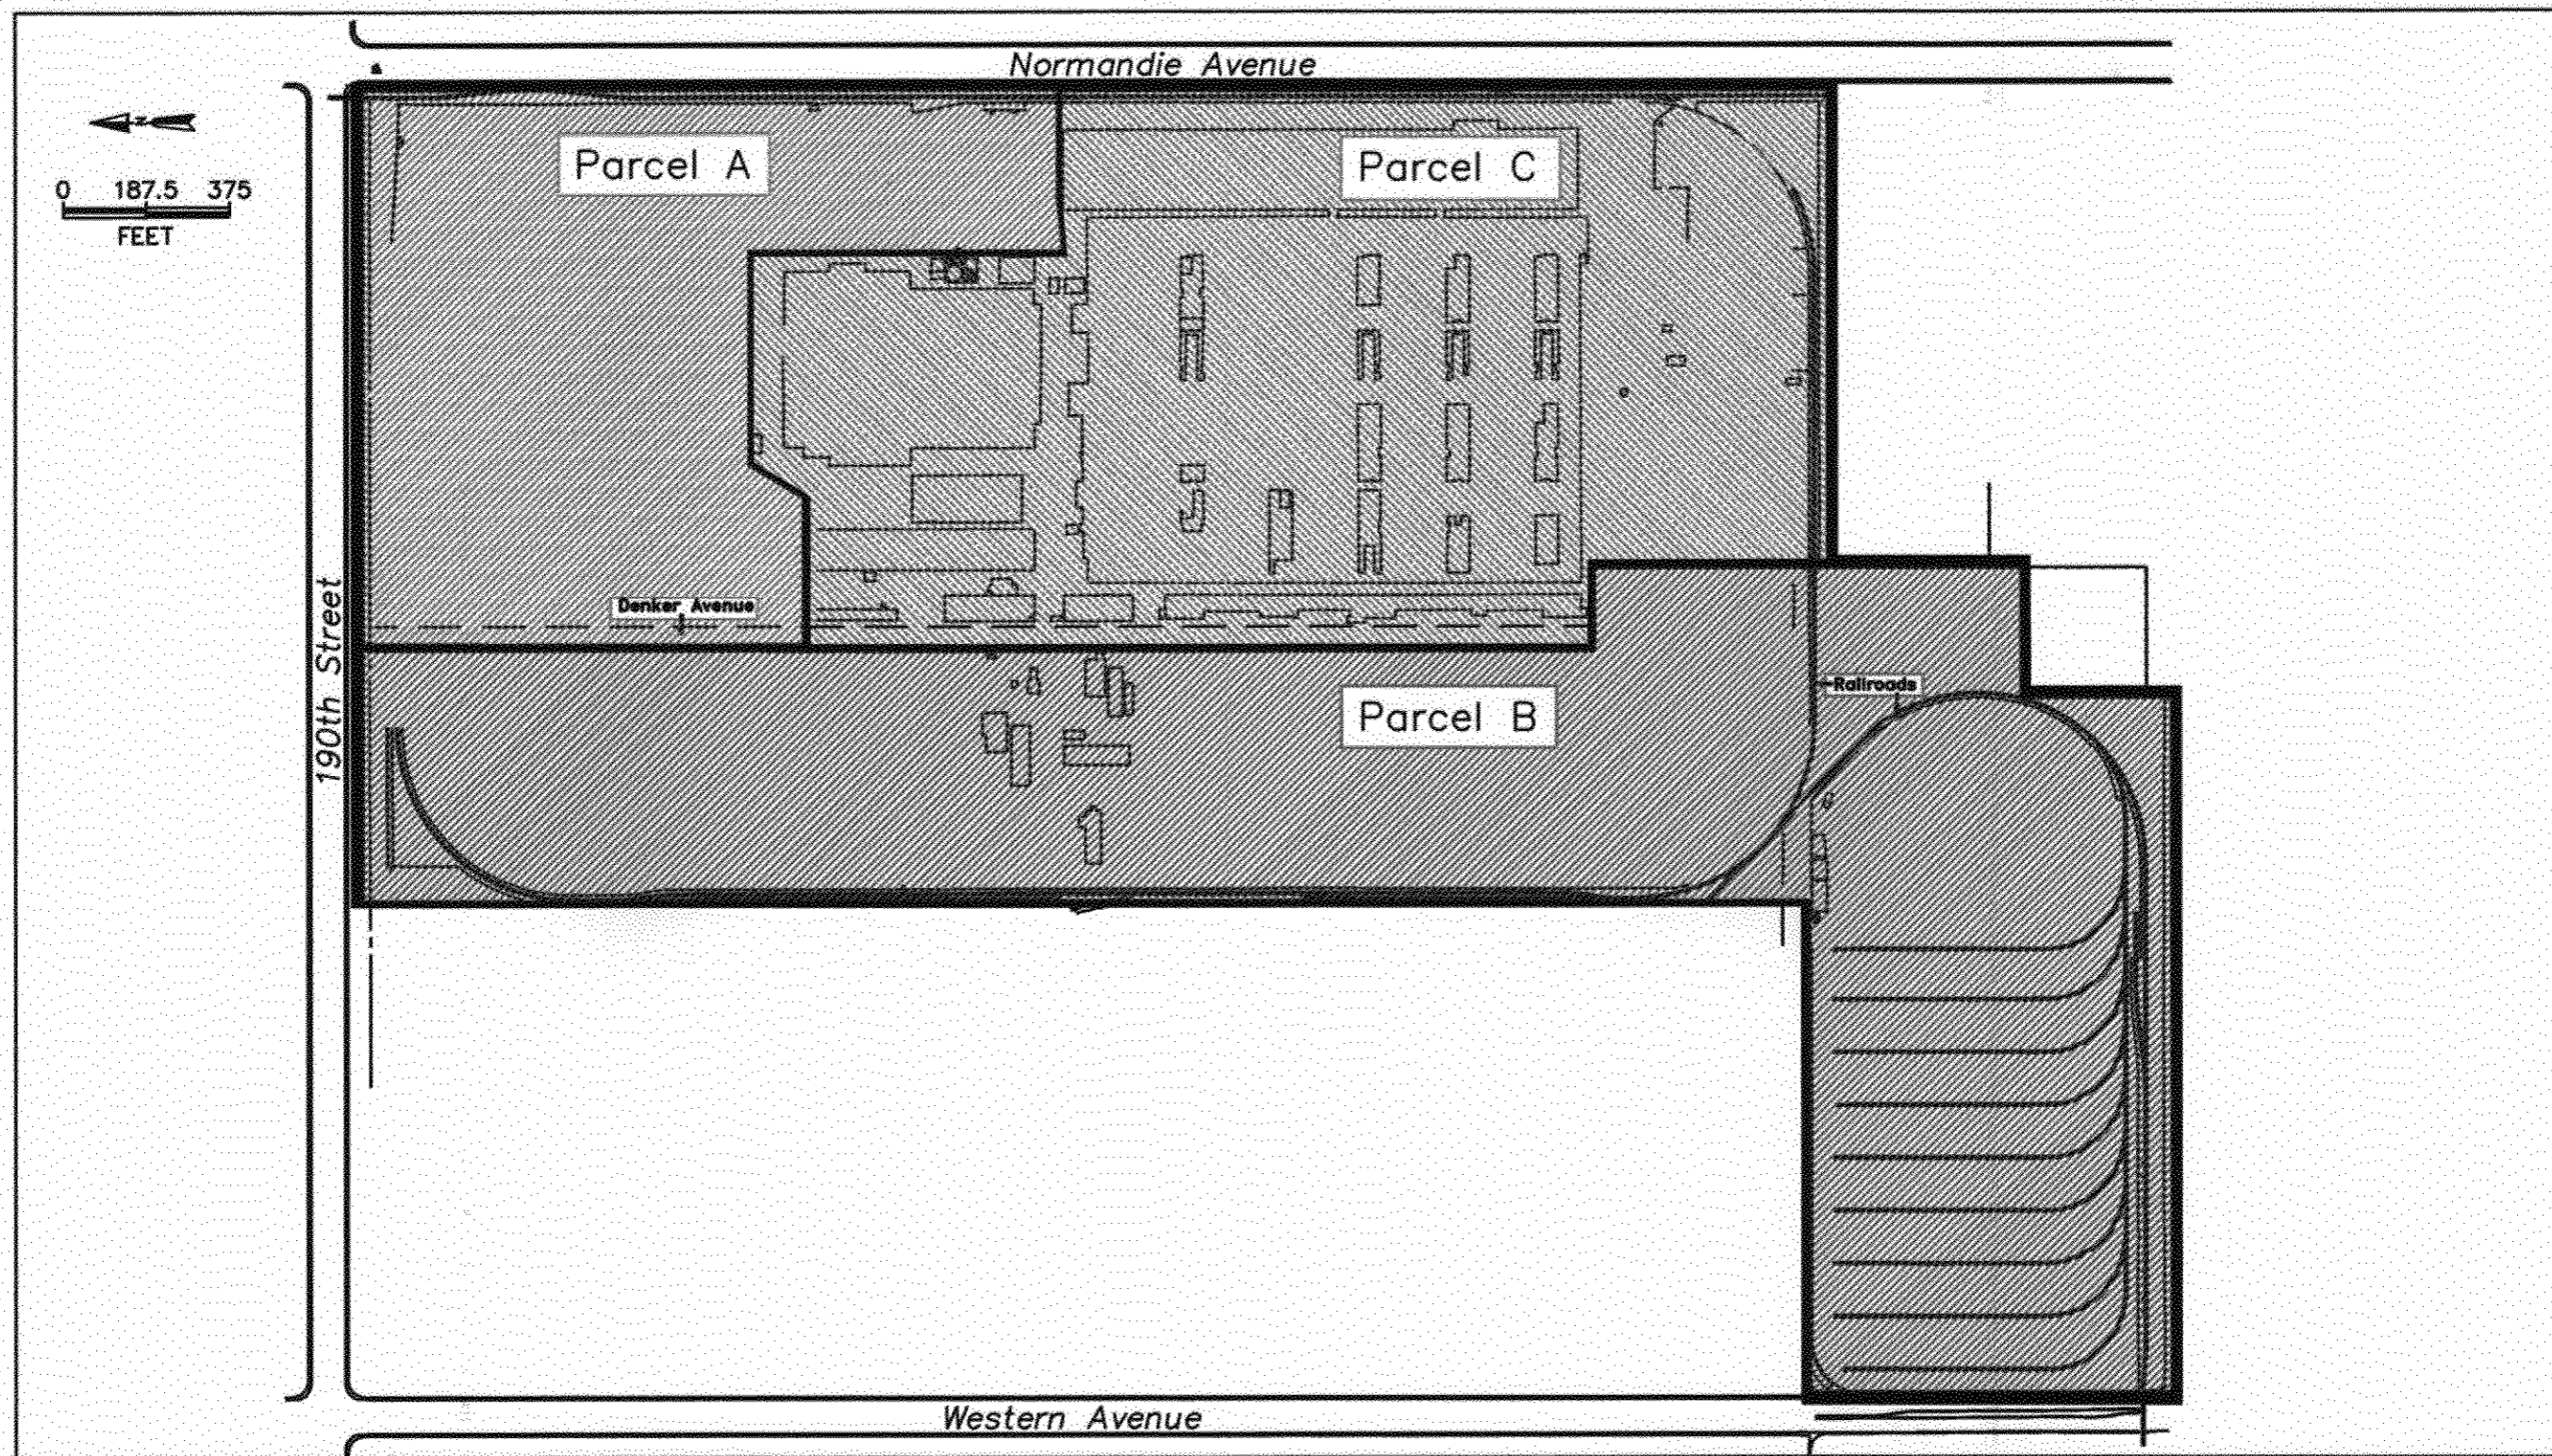
| DATE: 3-25-98 | REV.: 2 | FIGURE NO.: 1-2 |

TITLE:
 Boeing C-6 Facility
 Parcels A, B, and C

As shown in Figure 1-2, the site has been divided into three parcels. Redevelopment of the northeastern portion of the property, Parcel A, began in 1996 and is ongoing, while redevelopment of the western portion, Parcel B, has just begun. The southern portion, Parcel C, will be redeveloped at a later date. As part of the cleanup and redevelopment effort, environmental samples will be collected and analyzed for constituents consistent with past and present site operations. Analytical results obtained from the sampling will be used to determine which areas (if any) contain constituents at levels requiring removal and/or treatment. This sampling and analysis plan (SAP) presents the approach, objectives, and procedures to be implemented for Parcel B.

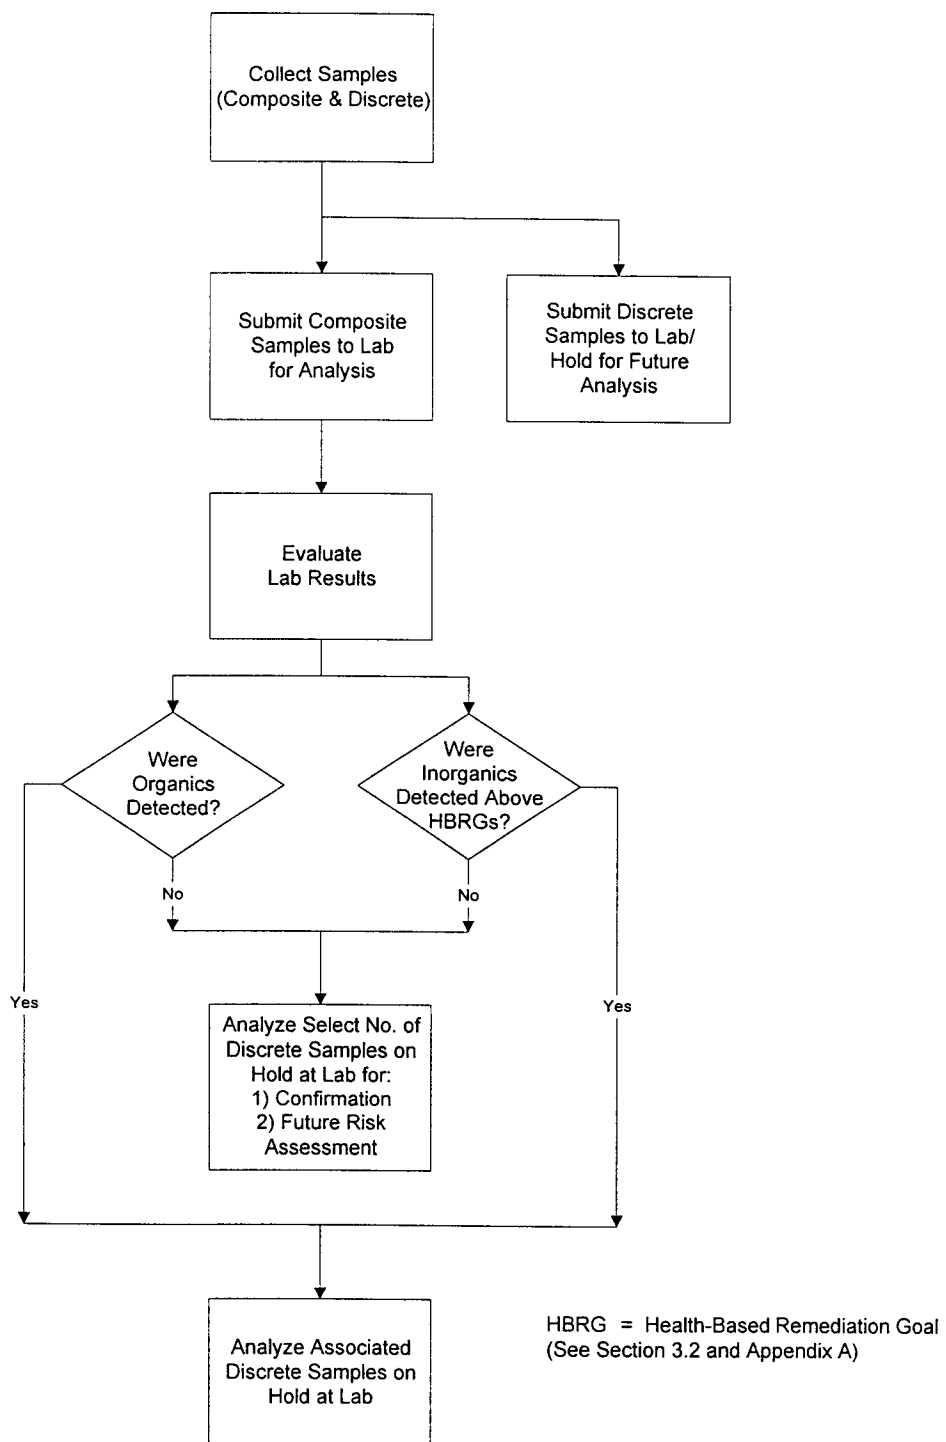
FIGURE 3-1. PARCEL B SUPPLEMENTAL SAMPLING AND ANALYSIS APPROACH
